EXPERIMENTAL POLYURETHANE FOAM ROOF SYSTEMS - II(U)
NAVAL CIVIL ENGINEERING LAB PORT HUENEME CA
R L ALUMBAUGH ET AL. JAN 83 CEL-TN-1656

TITLE: EXPERIMENTAL POLYURETHANE FOAM
ROOF SYSTEMS - II

AUTHOR: R. L. Alumbaugh, J. R. Keeton, and E. F. Humm

DATE: January 1983

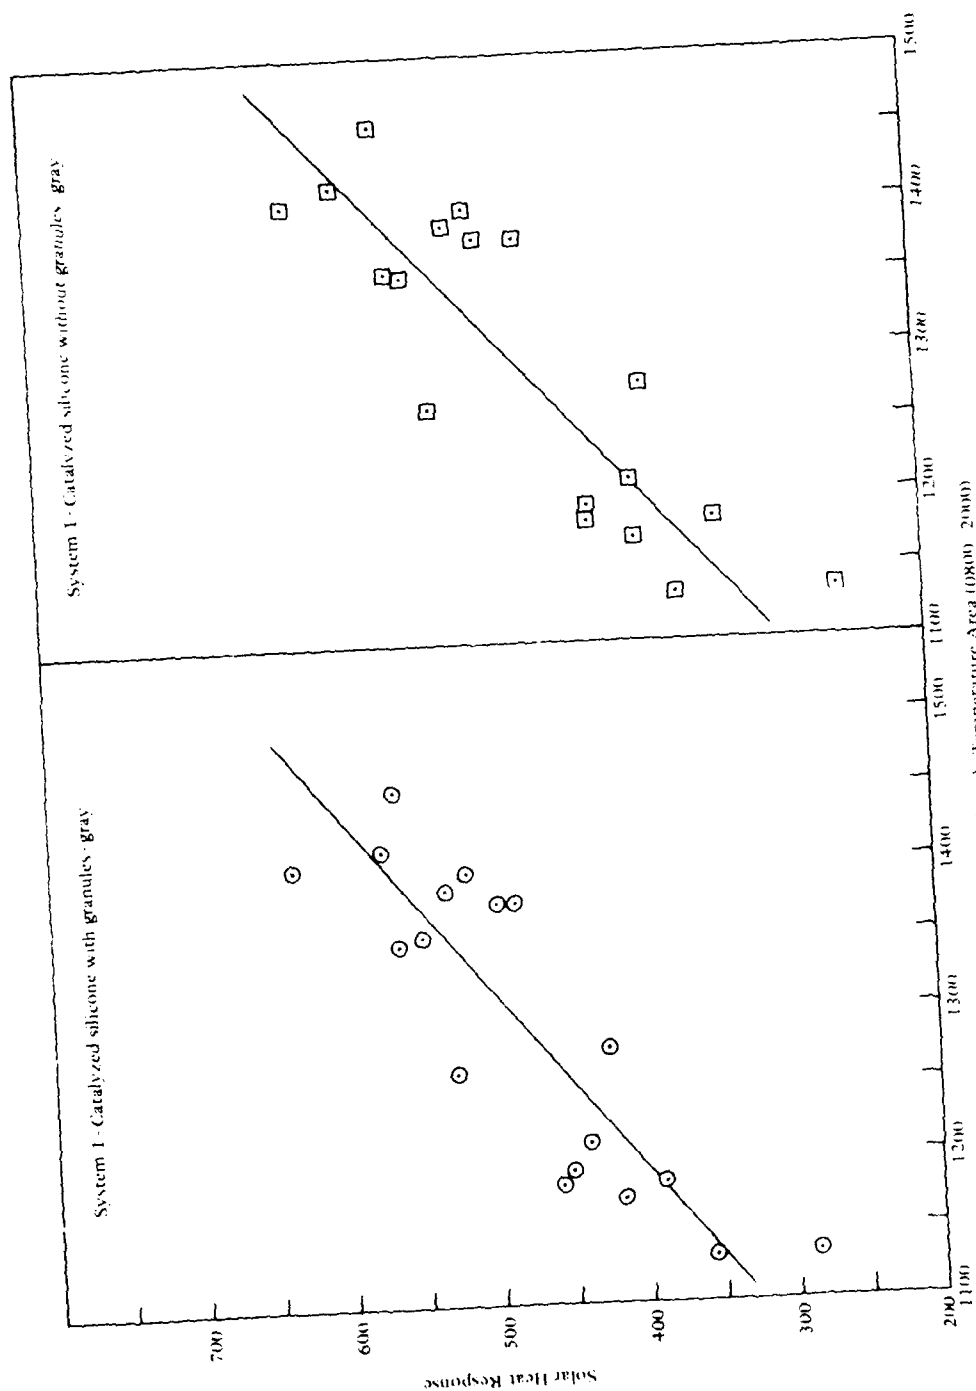
Figure 22 Solar heat response on catalyzed silicone roof sections.

Figure 22 shows solar heat response for the System 1 sections. The lines drawn are approximate least squares lines for the points shown. They are drawn only to indicate trends and do not imply that they are representative of all possible points of solar heat response. The only difference in the top surfaces of the two sections shown in Figure 22 is that the left portion has granules and the right portion does not. Points plotted in Figure 22 are listed in Columns 2 and 3 of Table 6.

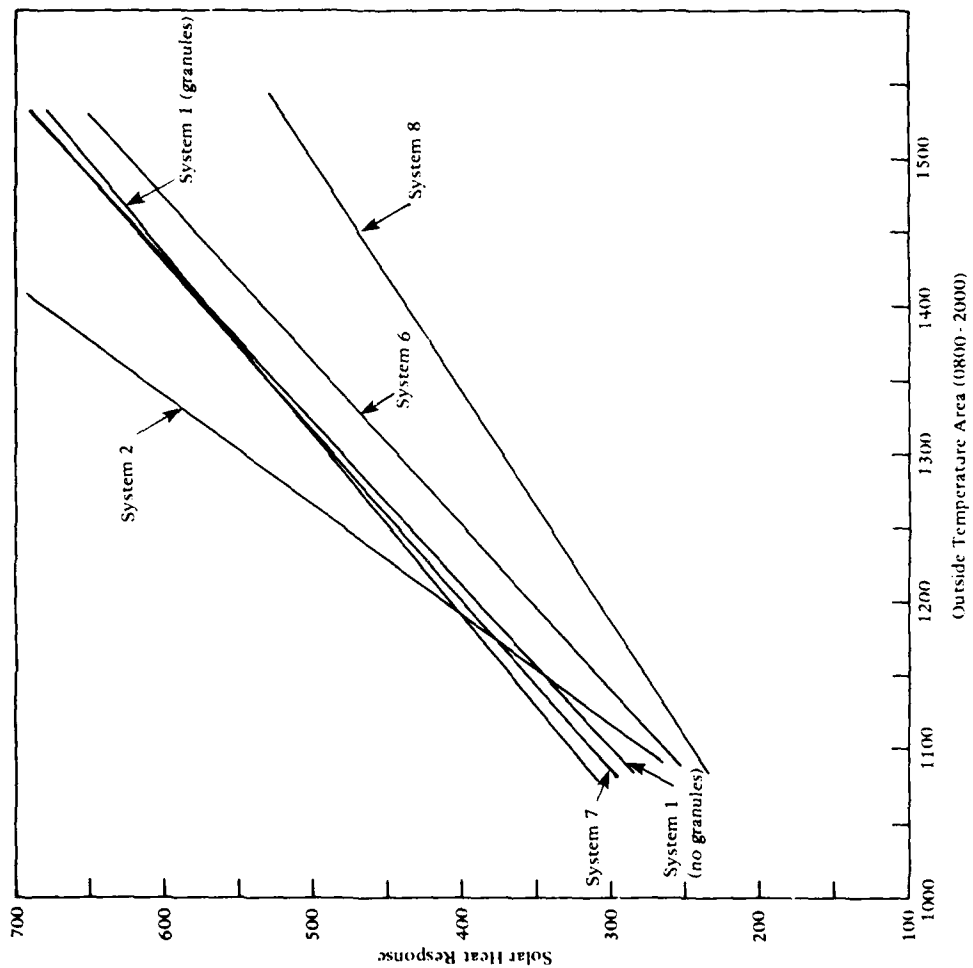
Figure 25. Solar heat response on all roofs, summers of 1978, 1979, 1980.

Figure 25 shows all the least squares lines from Figures 22-24. System 8, white catalyzed urethane with white granules, shows the lowest values of solar heat response. This coating system maintained its original white color longer than any of the other coatings. The highest values were in System 2, moisture-curing silicone without granules. Although this coating system was originally white, the silicone top surface soon began to soil and within a few months it had become a dingy gray. When the coatings were first sprayed, roof temperatures at the top surface (above the foam) were about 20° to 30°F cooler in the white silicone of System 2 than in the gray catalyzed silicone of System 1. In a few months, however, the top surface temperatures were almost the same in the two coatings, due to the darkening of the moisture-curing silicone of System 2.

The second lowest solar heat response in Figure 25 was in System 6 which is the same moisture-curing silicone used in System 2, the difference between the two systems being the white roofing granules applied in System 6. Graying of the top surface of System 6 has been much less severe than in System 2, partly because the white roofing granules do not discolor and partly because the presence of the granules reduces the exposed surface area of the silicone. Figure 25 indicates that all three of the gray coating systems (1 with and without granules, and 7 without granules) show about the same values of solar heat response. It should be emphasized that solar heat response is a direct measure of the effect of the sun's heat upon the roof.
